SAMPLING AND ANALYSIS

Report No. MA-ENV-820-96003-D Contract No. DTMA91-93-C-00004

Maritime Administration

JULY 1997

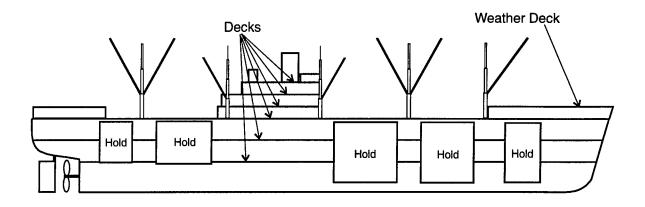
Figure 1. Typical Cargo Ship

quarters are located). A simplified drawing showing the arrangement of the decks and holds of a typical cargo ship is presented as Figure 1.

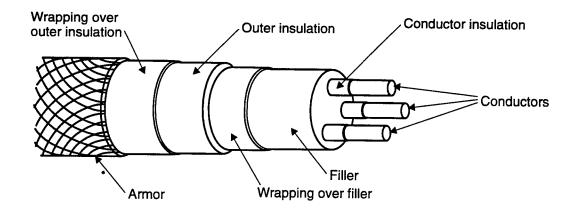
Figure 2. Typical Electric Cable

Based on its appearance, most of the cable in EXPORT CHALLENGER and SHIRLEY LYKES appears to conform to Institute of Electric and Electronic Engineers (IEEE) Specification 45, Type A/Z.¹³ This is a standard commercial specification for shipboard cables used at the time of construction of these ships. Some of the cable in WAYNE VICTORY appears similar to that in EXPORT CHALLENGER and SHIRLEY LYKES, but much of it was built to an earlier, unknown specification calling for an outer lead cover in addition to armor braid and plastic or rubber insulation. Typical cable construction used in EXPORT CHALLENGER and SHIRLEY LYKES is illustrated below as Figure 2.

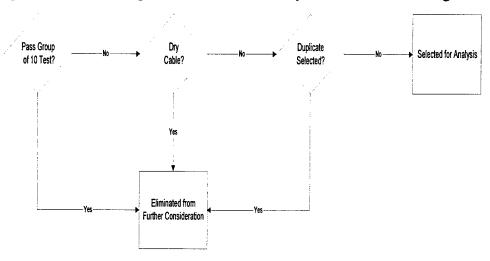
Figure 3. Process for the Selection of Cables for Further Analysis

• Elimination of dry cables. No grease or wax residues could be seen or felt in the internal components of many of the WAYNE VICTORY cables, unlike the samples from the other two ships, and all cables tested contained levels of PCBs less than 50 ppm. During extraction of the two groups of ten, the solvent did not attack the dry parts, instead extracting only the waxy matter. Therefore, any cable which was free of a waxy or greasy material was eliminated from further analysis. This reduced from 50 to 35 the number of individual cables analyzed for PCBs.

The overall process for selecting cables for further analysis is illustrated in Figure 3.

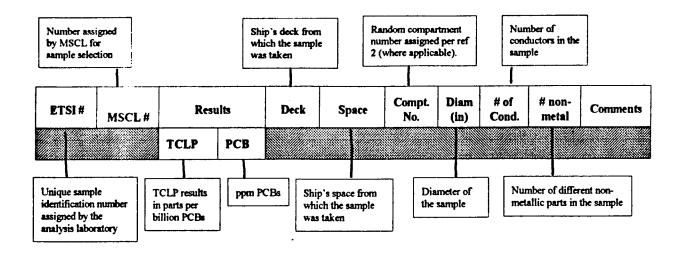
Figure 4. Key for Column Headings, Tables 9-11 and 13-18.

A summary of the results of the chemical analyses and physical inspections of the cables are shown in Tables 9, 10, and 11. The data in the tables are organized in order of the ETSI number, and concentrations of PCBs at or above 50 ppm are highlighted in gray. Table headings are explained in Figure 4. Cable samples that were not individually analyzed are recorded as either "dry," indicating the sample exhibited no greasy or waxy impregnant, or as a four-digit number in brackets. This four-digit number is the ETSI sample number of the sample's visual twin.

The results of the ventilation gasket sampling are shown in Tables 13, 14, and 15. (Refer back to Figure 4 for an explanation of the table headings.) Results have been organized into groups of similar materials, and each group is arranged in order of the ETSI sample number. Those containing PCBs at or above 50 ppm are highlighted in gray. Note that in all three ships, half or more of the ventilation system gaskets sampled contained concentrations of PCBs at or above 50 ppm.
